LINEAR STORAGE SOLUTIONS

INSPECTION REPORT ON BEHALF OF

Racking Inspection report

Date: Monday 2nd April 2018
Ref: QU-990199 - My Company (Europe) Ltd

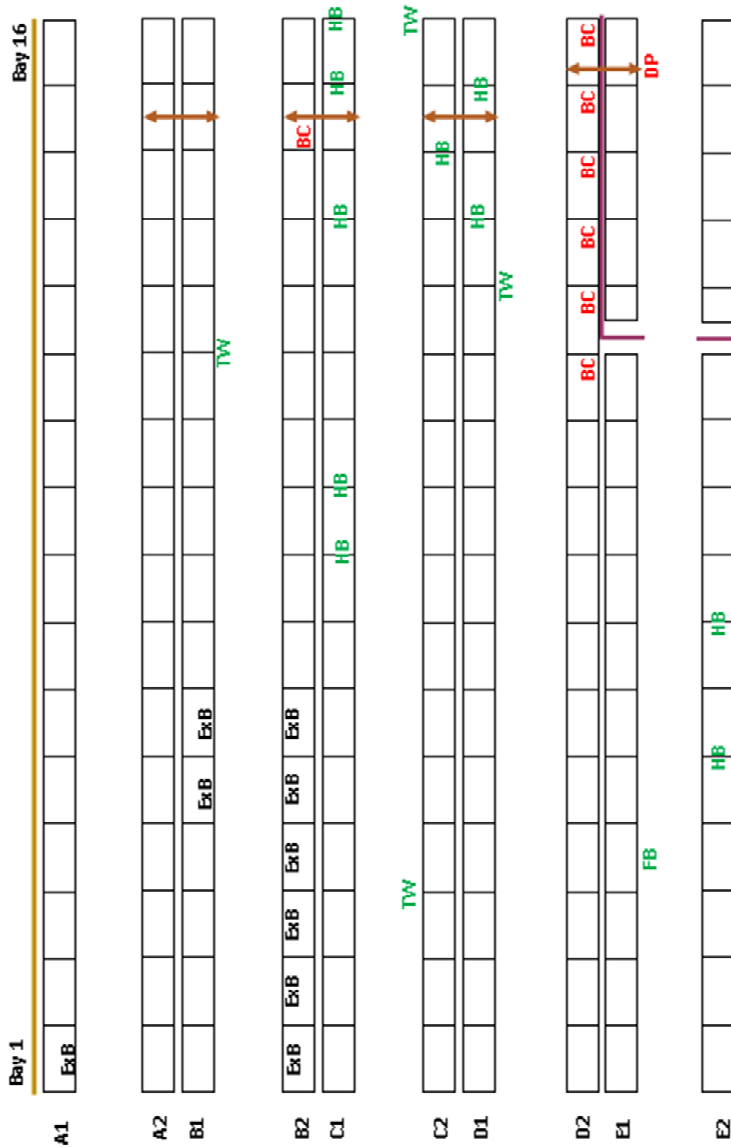
Appendix 5:

- DP = Decking Panel Missing Above Walkway
- BC = Beam Safety Clip Missing
- TW = Upright Slight Twist
- ExB = Extra Beam level Fitted
- HB = Horizontal Brace Slight Damage
- FB = Front Beam Slight Damage
